Report No. CG-D-21-86

CORROSIVE-WEAR OF BUOY CHAIN

U.S. COAST GUARD RESEARCH AND DEVELOPMENT CENTER
AVERY POINT, GROTON, CONNECTICUT 06340-6096

INTERIM REPORT
July 1986

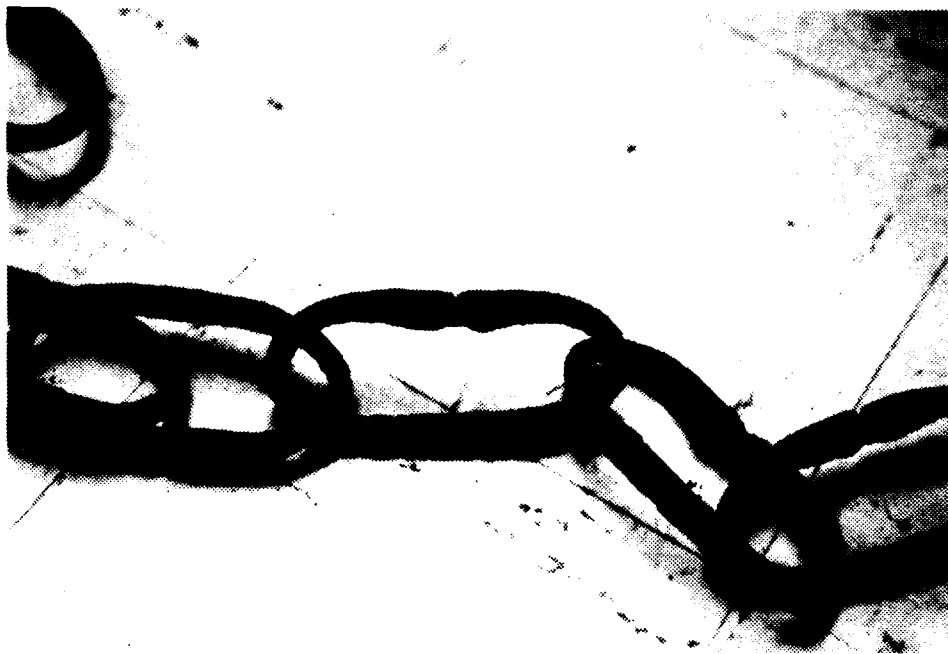
FIGURE 3. ABRADED BUOY CHAIN

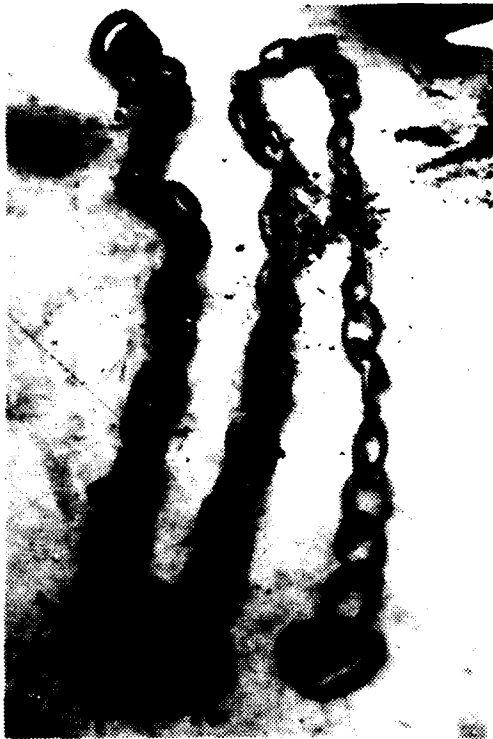
FIGURE 7. ABRADED BUOY CHAIN

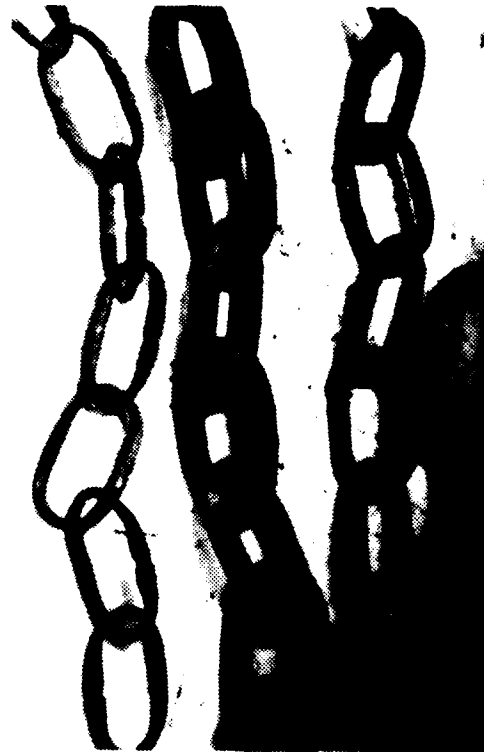
FIGURE 8. ABRADED BUOY CHAIN

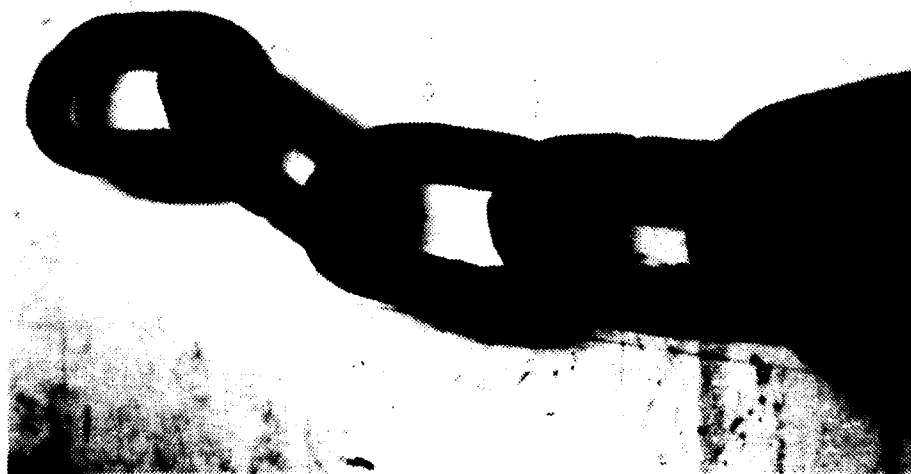
FIGURE 9. ABRADED BUOY CHAIN

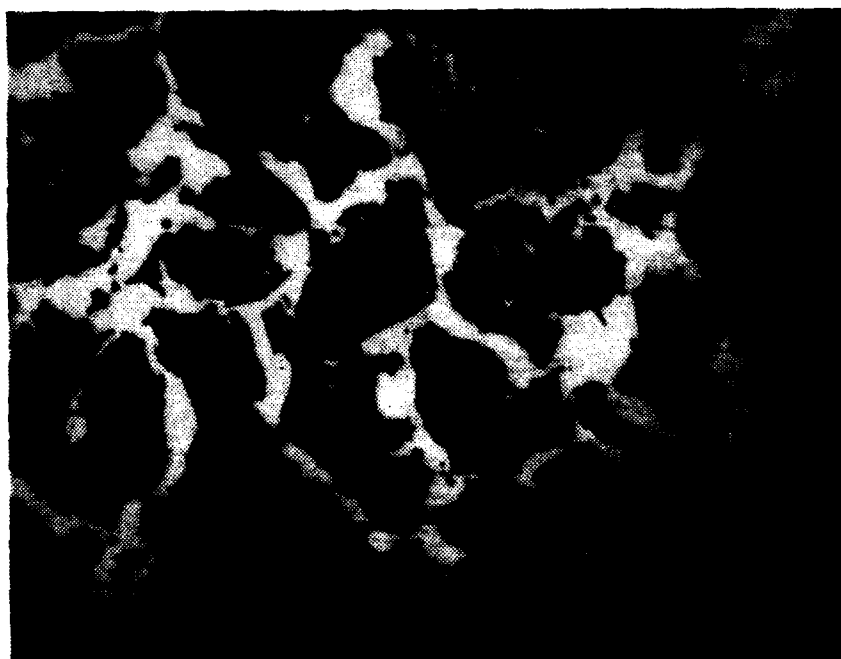
FIGURE 13. MICROSTRUCTURE PHOTO OF 1045 (H. MAG.) STEEL (X576)

pearlite in the microstructure as a result of the carbon content increase can be seen in Figures 12 and 13, where it is visible as the dark areas in the photographs.

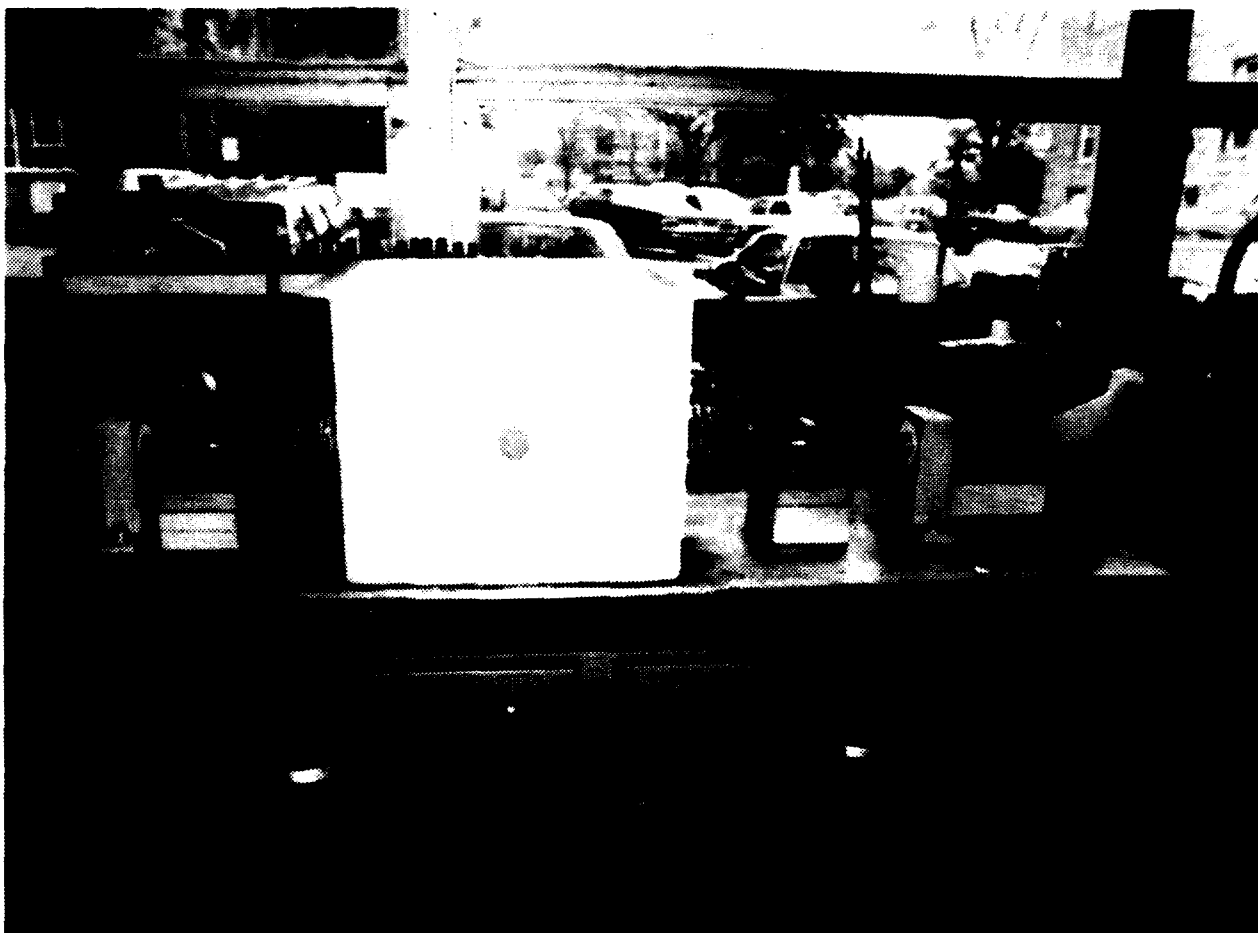
FIGURE 22. CORROSIVE-WEAR TESTING APPARATUS: EXPERIMENT B

The design features of the apparatus allowed only for reciprocating motion of the specimen on the whetstone. Linear bearings supported the weight of the drive shaft and also restricted the shaft movements to linear and rotational motions. Horizontal keyways cut into both sides of the drive shaft at each end contained teflon keys which passed through the teflon shaft bushing guides. These restricted rotation of the shaft. The teflon specimen carriage was attached to the shaft by four screws which tightened the carriage around the shaft. A pin passing through the carriage and shaft insured that no motion of the carriage occurred along or about the shaft. The specimen carriage also contained an aluminum key which matched keyways cut into the steel specimens. Movement of the specimen was limited to a vertical motion. The steel spring in the specimen carriage controlled the vertical motion and kept the specimen in contact with the whetstone.
